# Inspection Report

123 Main Street

Anywhere IL

**Dunsing Inspections**

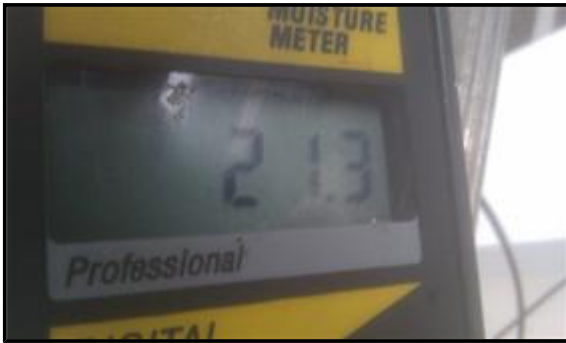
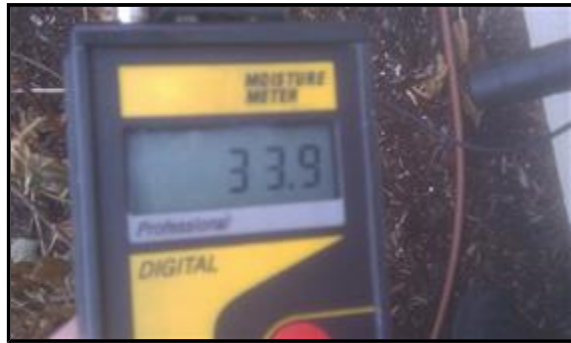
**1.0** Elevated moisture readings were found a some areas (19% or over). Repairs are needed there to prevent ongoing moisture penetration. Some soft substrate is noted at the rear wall, deck and side stoop. Removal of the EIFS will be required at these areas.

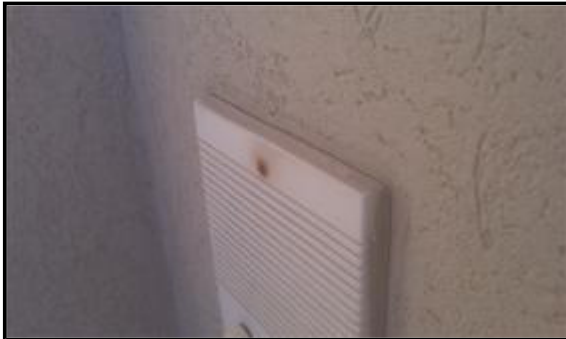
1.1 Picture 1

**1.1 Re-seal at rear deck speaker**

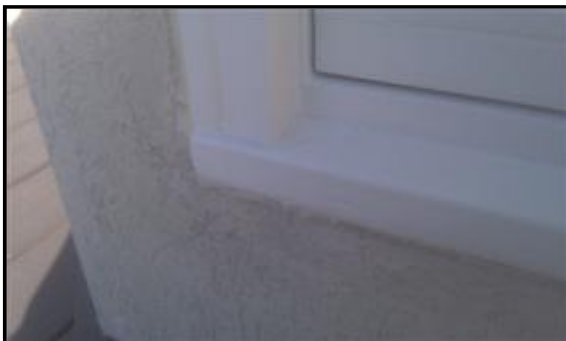
1.3 Picture 1

**1.3 Window miters are well sealed**

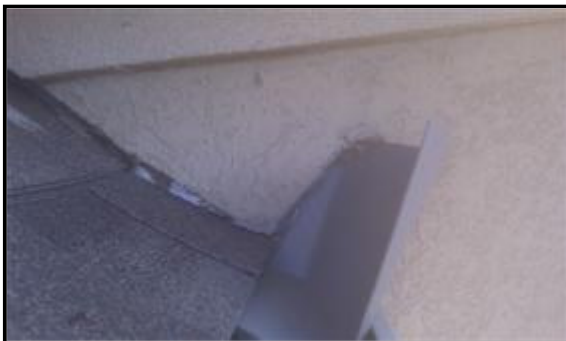
1.8 Picture 1

**1.8 Kickout flashings are working properly where installed**

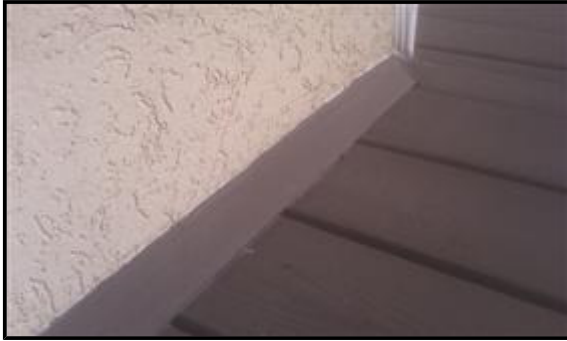
1.9 Picture 1

**1.9 The deck installation where it is attached to the house is not done properly. Decks are a very vulnerable area for moisture entry. There is a special flashing configuration that is required for this area. See the addendum detail for a look at how the system should have been installed. It appears that there has been a**

wood trim added at the wall/deck joint. We were unable to take any moisture readings below the deck. However, we did find ant and moisture problems at one area below the sliding door area. Repair is recommended to prevent ongoing moisture penetration there. This may involve removal of some deck boards so that a proper flashing can be installed.

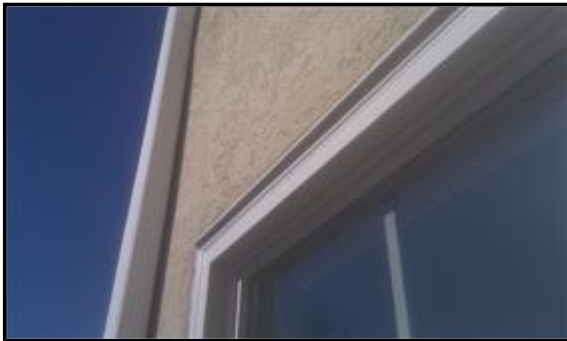
1.13 Picture 1

**1.13** Window head flashings are properly installed

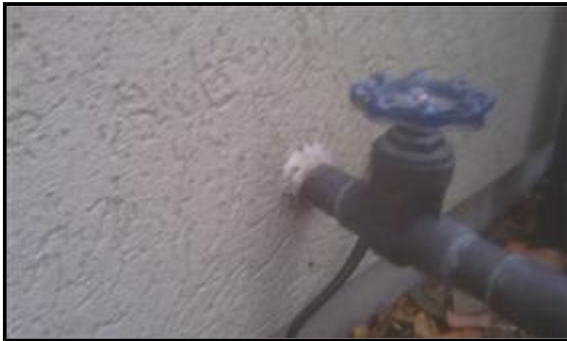
1.18 Picture 1

**1.18** Utilities are sealed properly

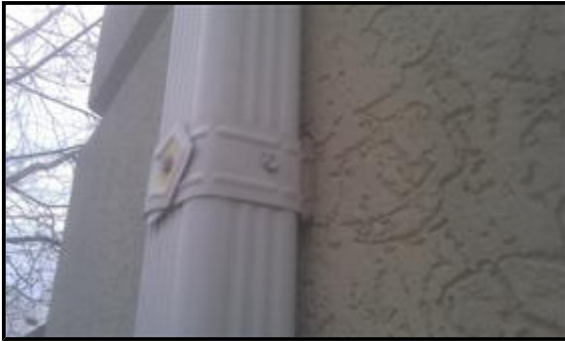
1.20 Picture 1

**1.20** Downspouts are sealed properly

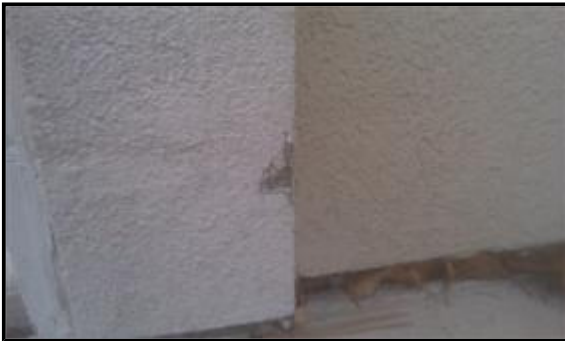
1.23 Picture 1

**1.23** There were small areas noted of impact damage. These areas should be properly repaired following EIFS manufacturer's instructions.

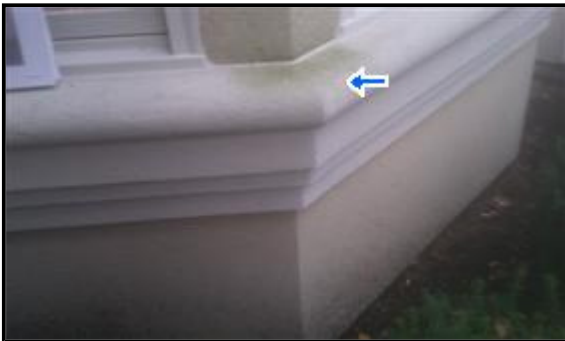
1.27 Picture 1

**1.27** Mildew and algae growth were noted at some areas. This can be cleaned off as described in the maintenance portion of this report.

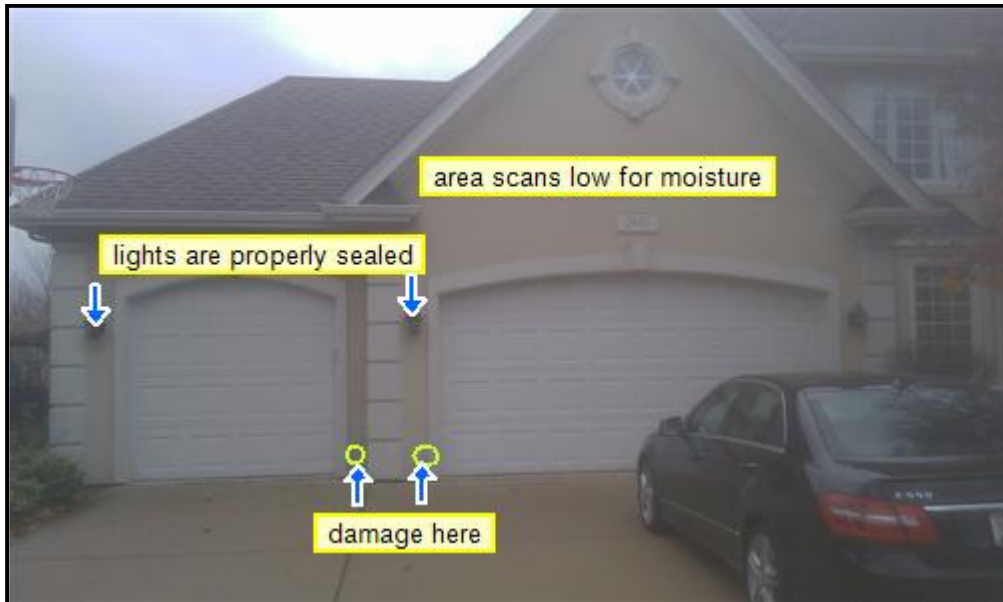
The photo below shows moisture readings. Any photos further down in this section show specific areas of concern. Note that these areas may be common defects at other areas of the building, not simply this location only.

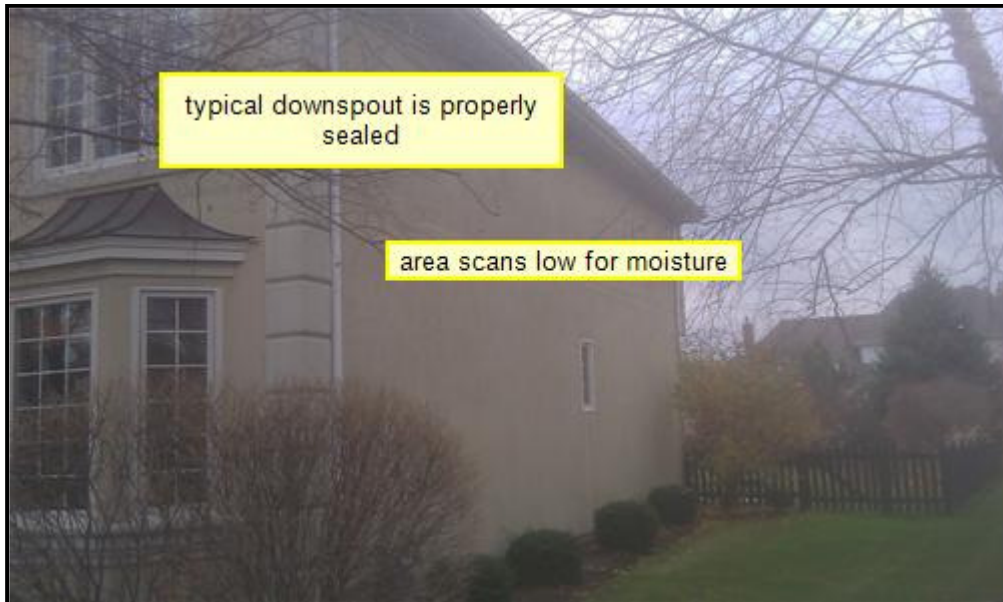
The photo below shows moisture readings. Any photos further down in this section show specific areas of concern. Note that these areas may be common defects at other areas of the building, not simply this location only.

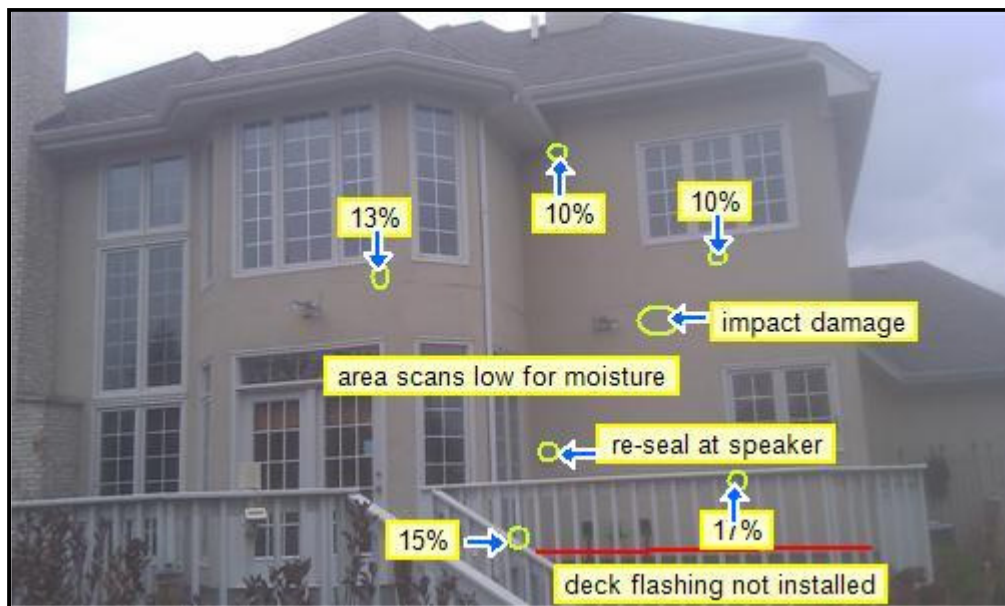
The photo below shows moisture readings. Any photos further down in this section show specific areas of concern. Note that these areas may be common defects at other areas of the building, not simply this location only.

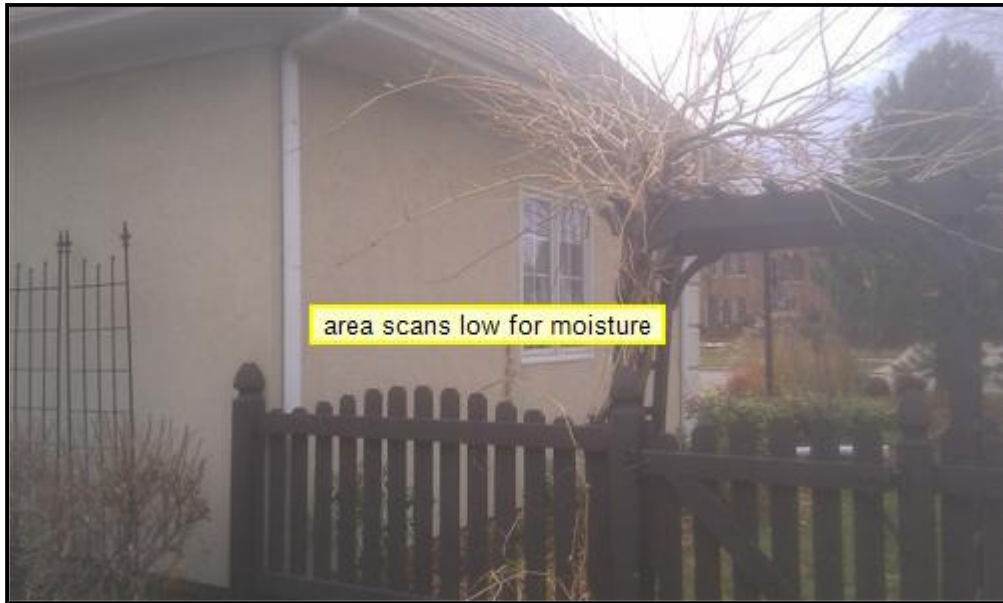
The photo below shows moisture readings. Any photos further down in this section show specific areas of concern. Note that these areas may be common defects at other areas of the building, not simply this location only.
