# Inspection report for the property at Medical building sample report

This report is prepared exclusively for **Sample Report**  
Inspected On: **04-23-2024**

This is a medical facility. There are separate offices for counseling, dentist and other medical professionals. Some of the systems in the building are aging and will require updating.

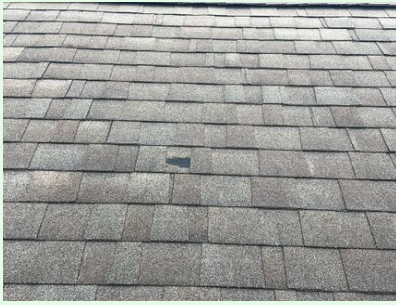
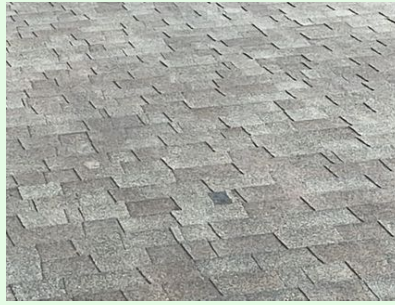
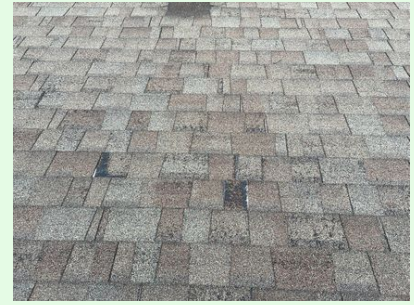
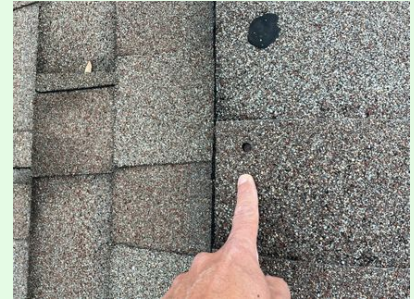
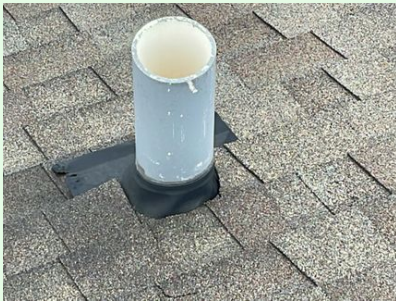
**(R-2) Budget For Replacement: OLD ROOF** This roof is near the end of its expected service life. Granular loss, tears, blemishes, exposed nails and patches are noted. Budget to replace the

roof soon.

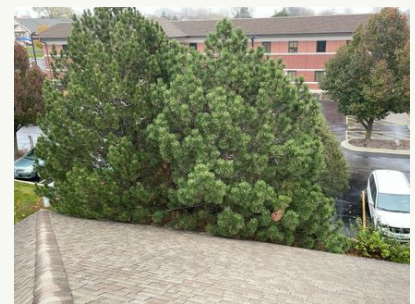
**Trim tree branches**- Tree branches that are touching the roof should be cut back to prevent damage and/or animal access.

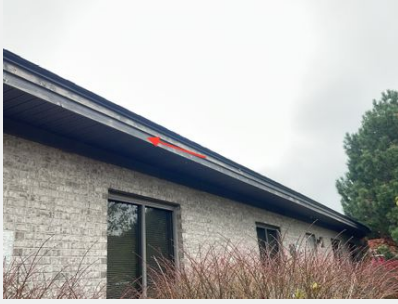
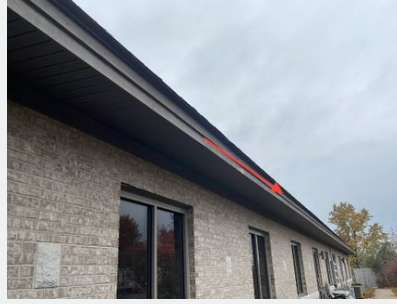
**(R-3) Improvement or Upgrade:** No gutters or downspouts are installed on the building. Gutters and drain lines are recommended on the home to prevent erosion of the soil and possibly water intrusion into the building.

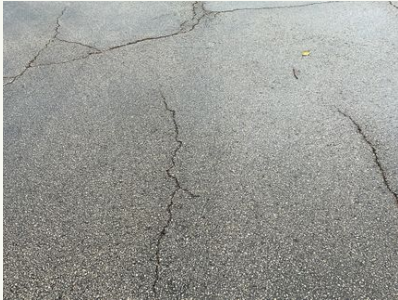
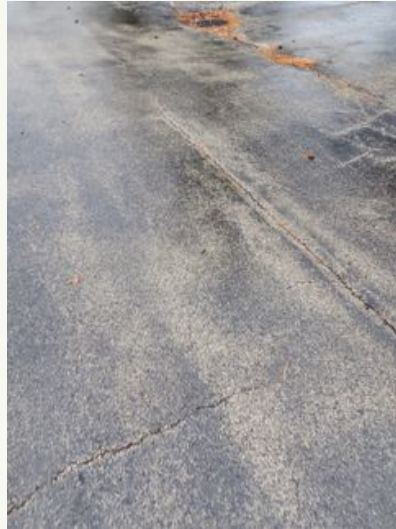
**(GDW-4) Maintenance Item:** Sealcoating of the asphalt parking area is needed. This is normal maintenance that will help to preserve the life of the driveway and parking area.

*Typical cracking of parking area*

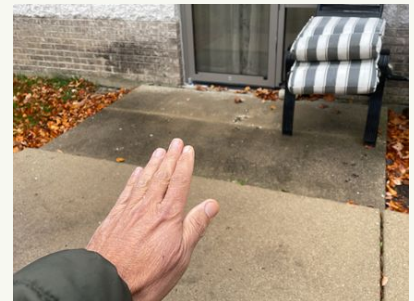
The walkway at the rear of the building is starting to settle. Repairs are needed to prevent a fall or trip hazard. A qualified contractor should review and repair as needed.

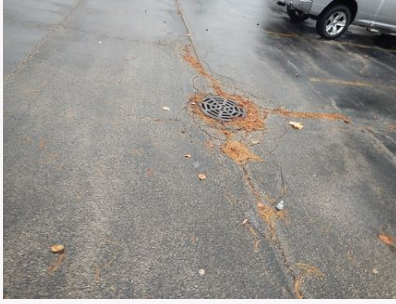
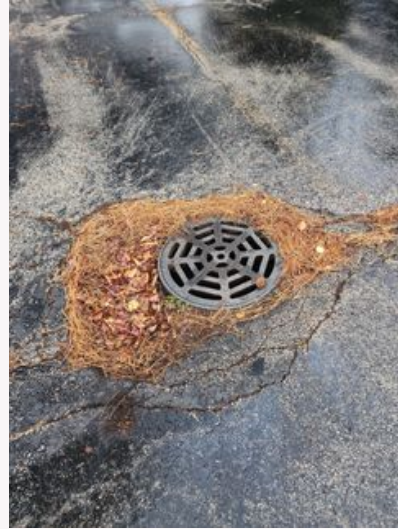
**(GDW-7) Items Not Working / Repair:** Some of the drains at the parking area have settled and are eroding. Repairs will be needed to ensure proper drainage. A paving contractor can make these repairs

*Settling at drain basin in parking area*

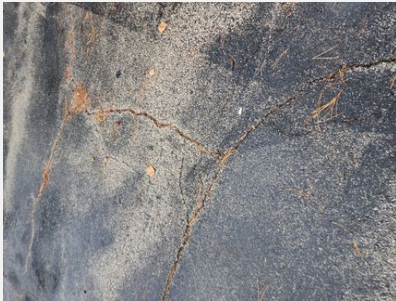
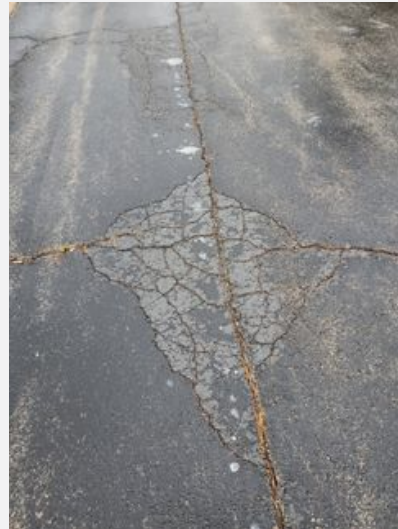
✧ **(GDW-3) Note:** Typical cracking is noted on the driveway. This is typically not a major concern. If the condition of the driveway worsens, a contractor should replace the driveway.

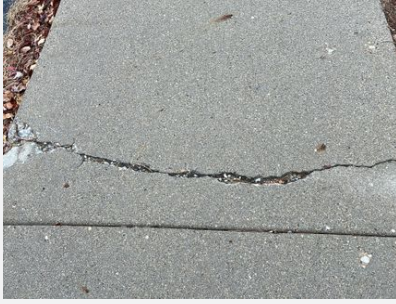
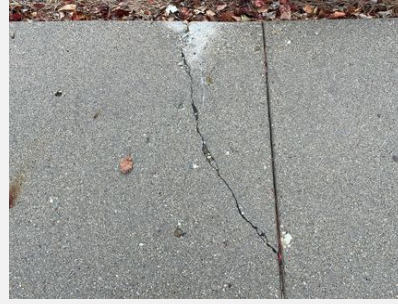
✧ **(GDW-5) Note:** Typical cracking is noted on the sidewalk(s). This is typically not a major concern. If the condition of the walkway worsens, a contractor should replace the walkway.

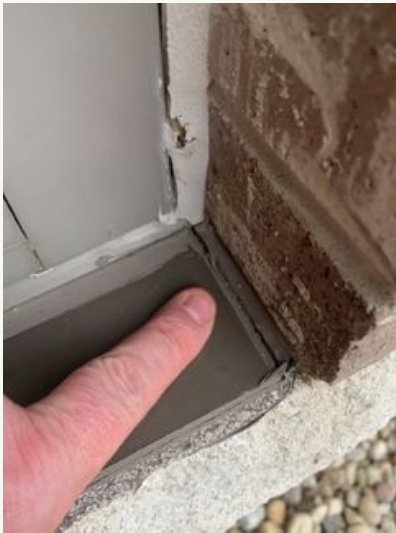
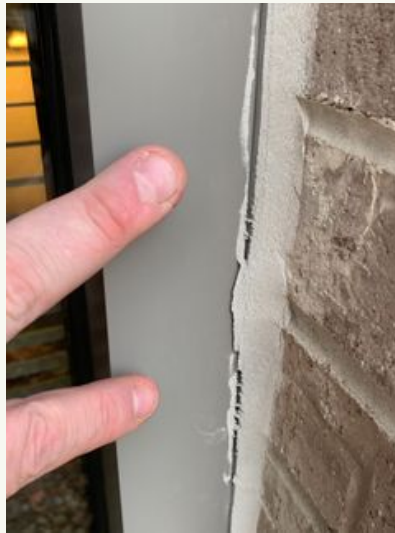
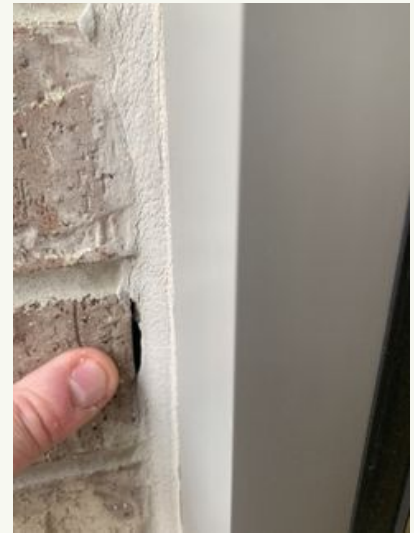
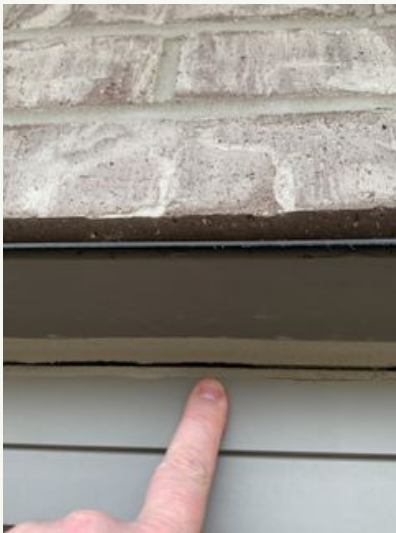
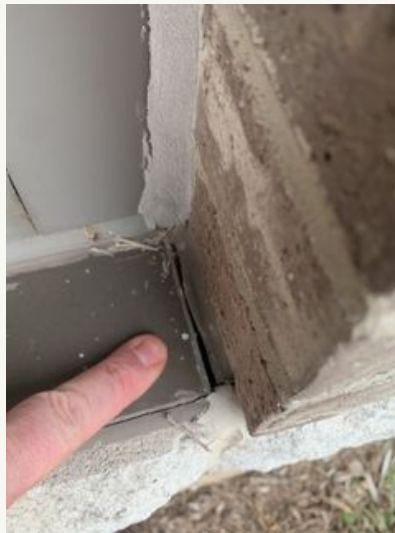
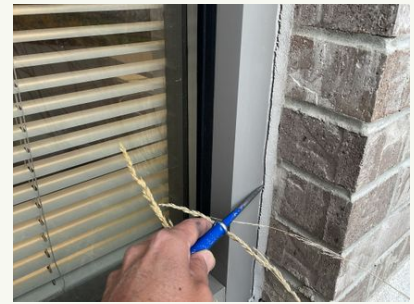
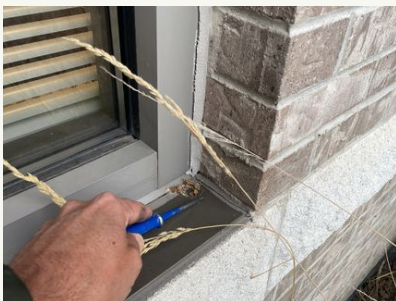
**(E1-2) Maintenance Item: Seal / Caulk at Windows-** Sealant has failed at several of the windows at the exterior of the home. A qualified contractor should removed and replace failed sealant to prevent water and air intrusion. NOTE: Most windows at the exterior will need caulking/

sealing.

*typical failed sealant at many areas*

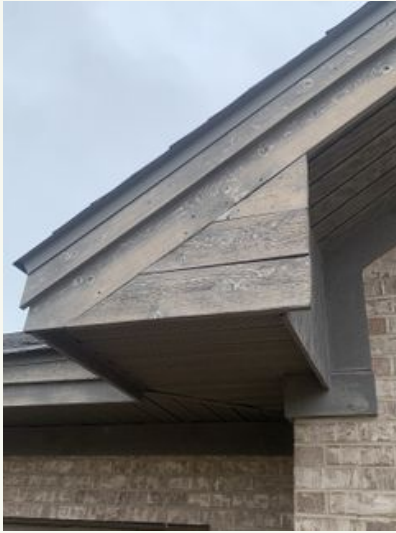
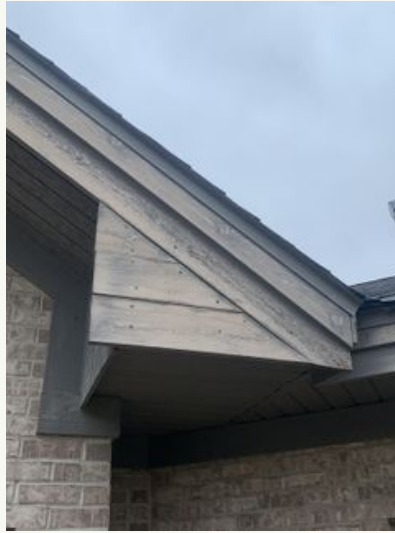
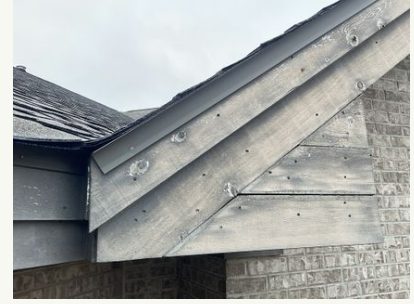
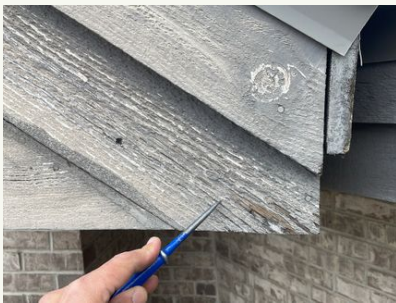
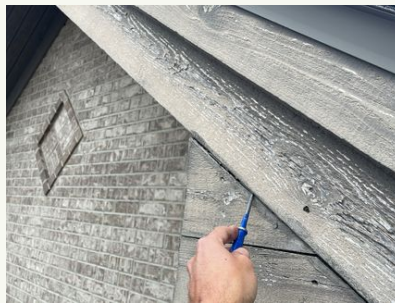
**🔧 (E1-3) Maintenance Item: **Painting needed****- Wood trim at several areas has failing and peeling paint or stain. Deterioration can eventually occur if this is not corrected. These areas should be re-stained.

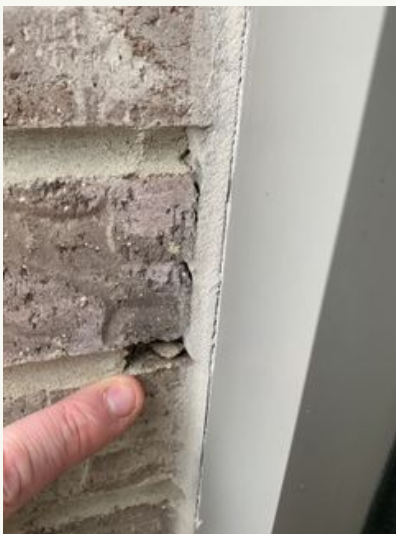
*Left of front entrance*

**🔧 (E1-4) Maintenance Item: Maintenance Needed-** Tuckpointing is needed on the exterior walls at some locations. Eroding mortar is usually caused by water flowing over areas of brickwork and washing away of the mortar, however, it is also a normal process that occurs on older masonry walls. Tuckpointing should involve removal of old mortar to a 3/4" to 1" depth and packing new mortar in. A qualified masonry contractor can perform this repair.

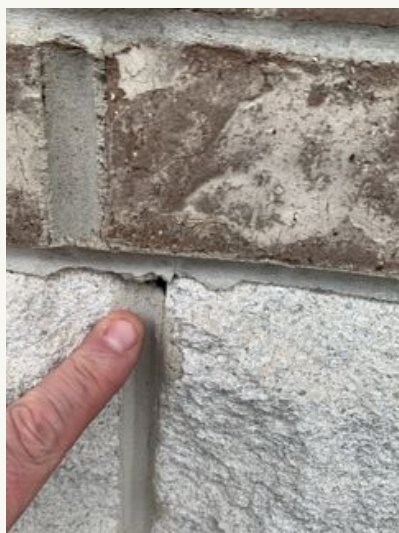
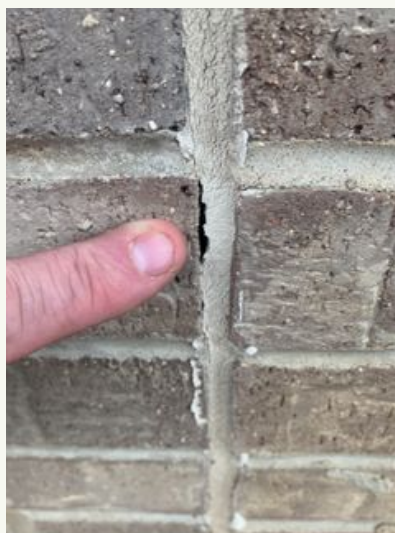
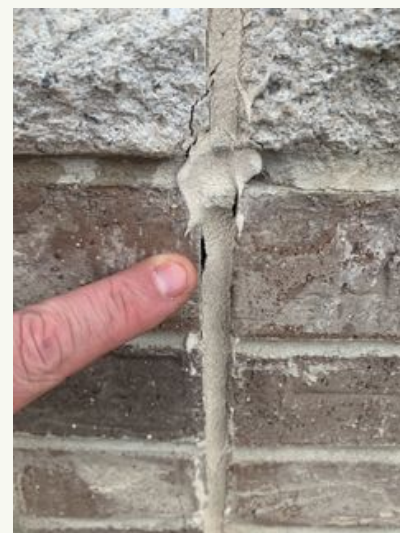
**(E1-5) Maintenance Item:** Caulking Needed at exterior at various areas

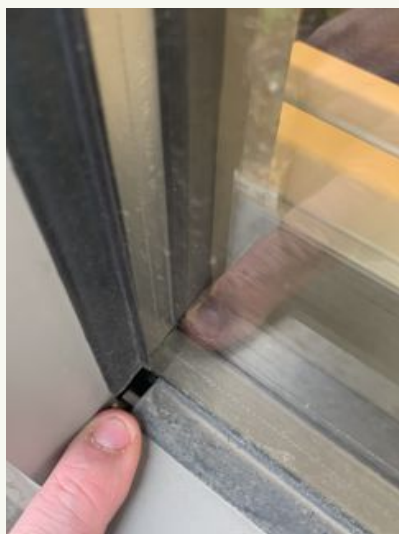
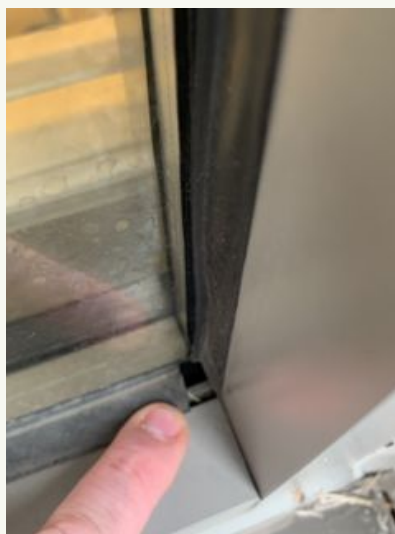
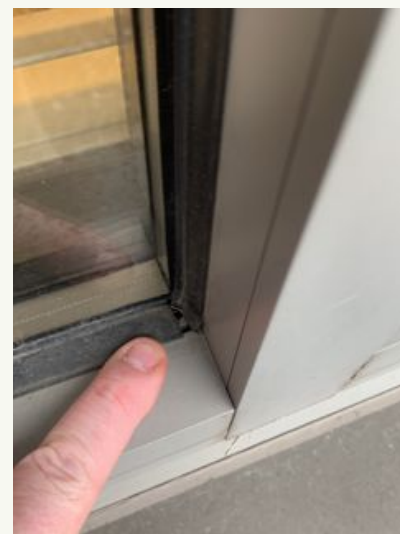
**(E1-6) Maintenance Item:** Windows have broken/missing pieces of plastic trim at the exterior. Water entry can occur. A window contractor should repair as needed.

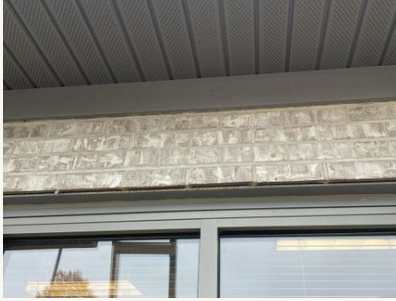
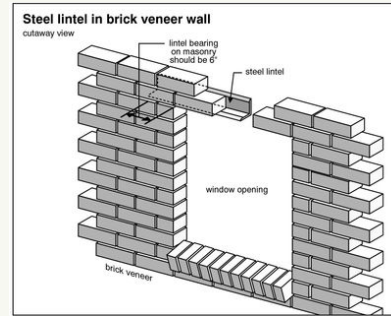
**🔧 (E1-7) Maintenance Item: Paint needed**- Many of the window lintels need paint. Any rust or loose paint should be cleaned prior to painting. The lintel is the steel above the windows that supports stone and masonry above the window. If left unpainted, the lintel can rust and deteriorate.

*Rust at lintel (typical many areas)*

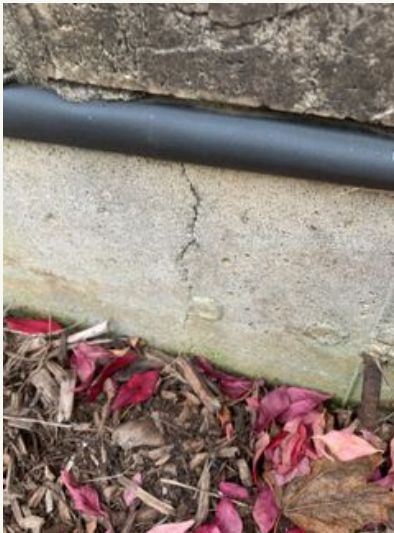
*north wall*

🔧 **(S-2) Maintenance Item: Wall Cracks**- There are typical cracks at some locations in the foundation slab. We recommend that these cracks be repaired to prevent seepage. Of course, if seepage occurs, a waterproofing contractor should be consulted immediately to seal the cracks. The methods used to seal these types of cracks are usually very dependable and often have a long term warranty.

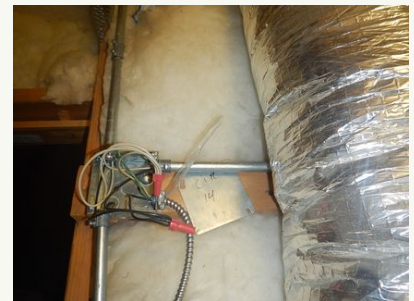
**Simple repair-** There is a missing cover plate at the Suite B attic space. All receptacles should have a proper cover. This is a simple repair.

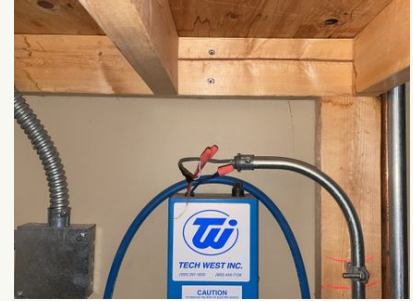
The Suite 1 air compressor is missing a connection box. Currently electric wires are exposed. A proper connection should be made. A qualified electrician can perform this work.

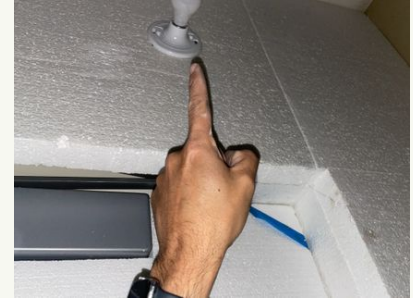
**Lights not working**- The light bulb is not working at the Suite A electric closet. We did not check to see if this is simply failed light bulb. Replacing bulb should be the first step in checking why the light is not working. If changing the light bulbs does not solve the issue, a qualified electrician should make repairs.

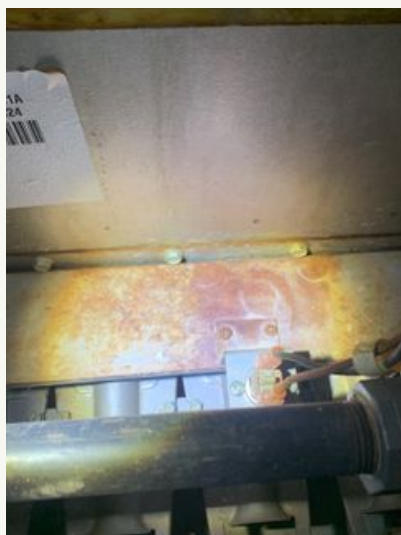
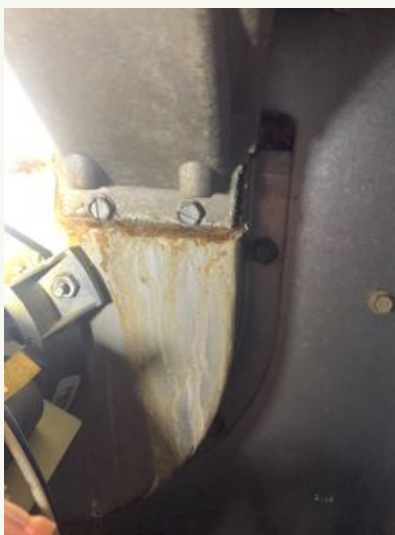
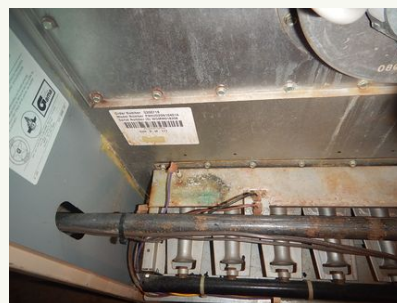
**(H-3) Maintenance Item: Rust at heating-** Minor rusting was noted in some areas of the furnace. No leaks were noted at the time of the inspection. Check with the owner about any information they may have with regard to the stains or any repairs that have been done. We recommend a qualified HVAC technician service the heating system NOW and once a year in the future.

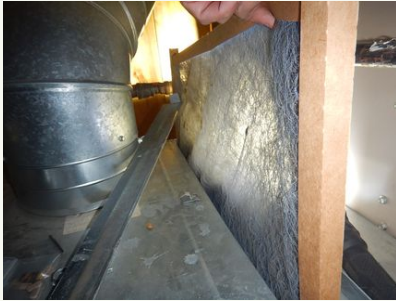
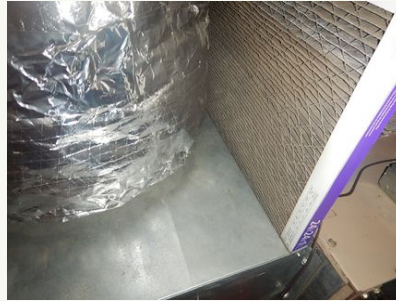
🔧 **(H-4) Maintenance Item: Dirty filter**- The filter for the heating system is dirty. This decreases its effectiveness, and blocks airflow. This can dramatically decrease the efficiency of the heating (and cooling system if present) and can increase energy usage.

- **SUGGESTION**: Change or wash the filters now, and at regular intervals thereafter. The filter should be replaced with a properly sized filter to ensure proper function. If the system has been operating in this condition for an extended period of time, service by an HVAC contractor is advised to check the cleanliness of the fan, evaporator coil, ducts, etc., and clean it as needed.

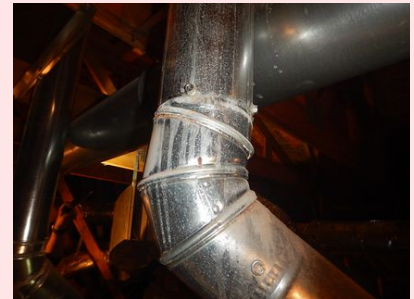
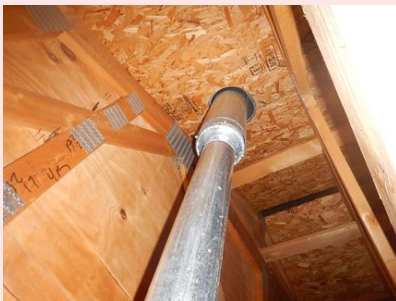
**Rust/Corrosion/Holes in vent-** The vent connector has rust, corrosion, or holes in it. This indicates that there is excessive moisture (most likely from condensation). This can cause the heating system to vent improperly. An HVAC contractor should make repairs to make the venting system safe.

**Rust/Corrosion/Holes in vent**- The vent connector has rust, corrosion, or holes in it. This indicates that there is excessive moisture (most likely from condensation). This can cause the heating system to vent improperly. An HVAC contractor should make repairs to make the venting system safe.

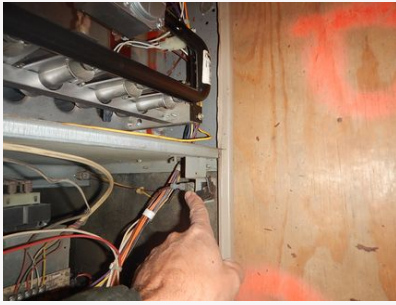
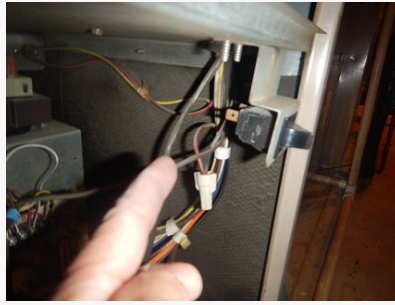
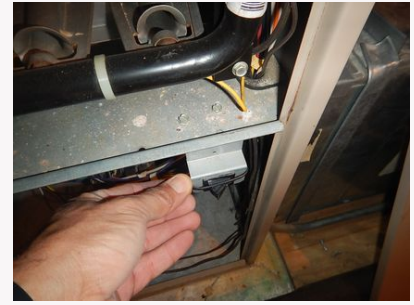
**Safety device bypassed-** The blower compartment safety interlock switch for the furnace has been disabled. The furnace is designed to shut down when the cover for the blower compartment is removed. We find this often, but as it is related to a safety device, we recommend that it be remedied. Tape, zip-ties, screws or other devices should be removed to allow the system to function as intended. An HVAC contractor should make immediate repairs.

🔧 **(H-5) Items Not Working / Repair: Safety device bypassed**- The blower compartment safety interlock switch for the furnace has been disabled. The furnace is designed to shut down when the cover for the blower compartment is removed. We find this often, but as it is related to a safety device, we recommend that it be remedied. Tape, zip-ties, screws or other devices should be removed to allow the system to function as intended. An HVAC contractor should make immediate

repairs.

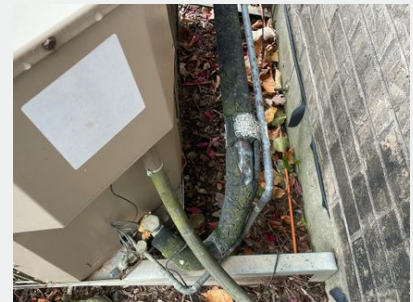
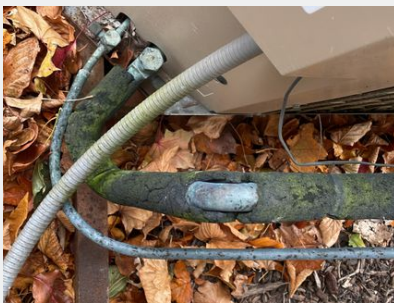
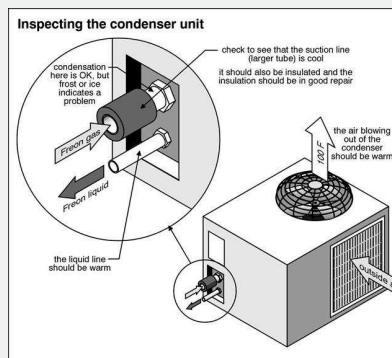
**🏠 (AC-3) Improvement or Upgrade:** The insulation on the suction lines at several of the condensers is missing. Missing insulation on a suction line can cause energy loss and condensation. A qualified HVAC technician should make repairs.

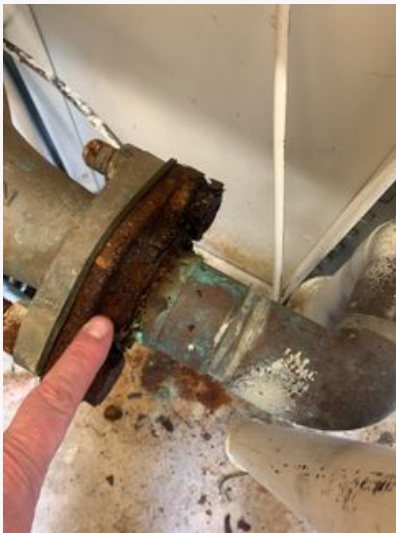
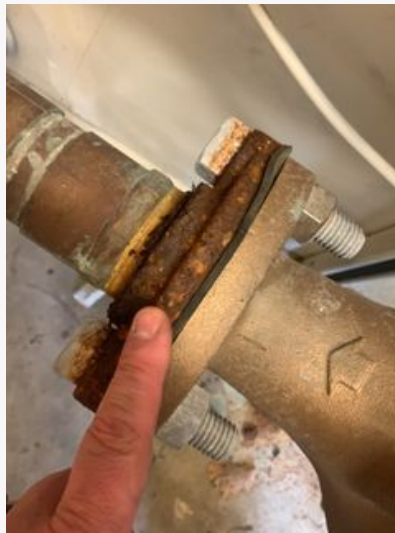
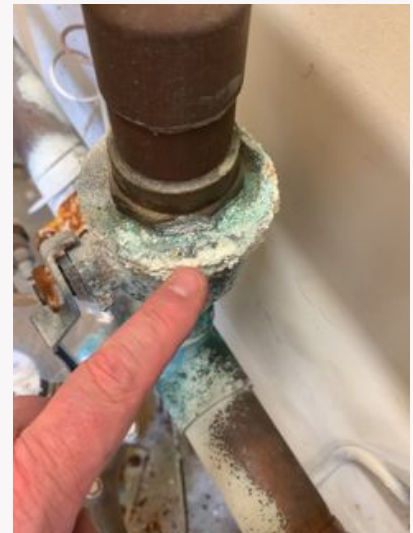
**Plumbing corrosion-** We found corrosion to the water piping at the main water shut off. This needs repair. A plumber should perform this work.

**🔧 (P-4) Items Not Working / Repair: Plumbing corrosion-** We found corrosion t the water piping at the main water shut off. This needs repair. A plumber should perform this work.

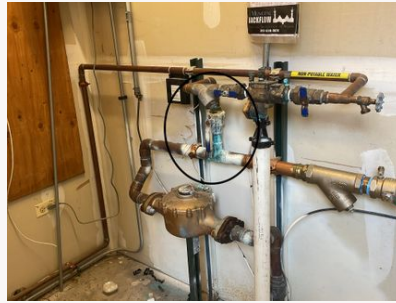
*note stains and corrosion at  
backflow preventer*

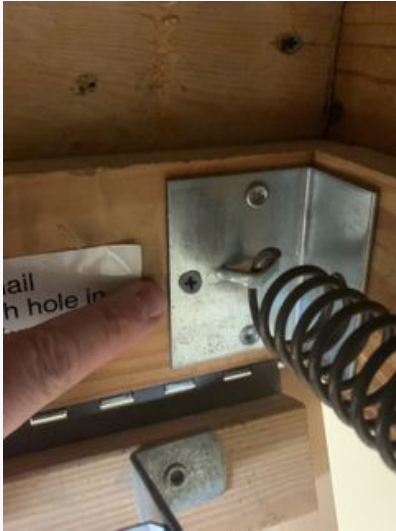
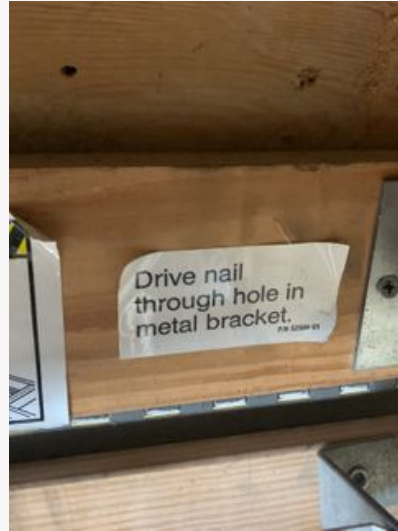
✂ (I-3) **Items Not Working / Repair:** The attic pull down stair is not properly secured with the correct hardware. Currently there is a screw installed. A nail should be used in this area.

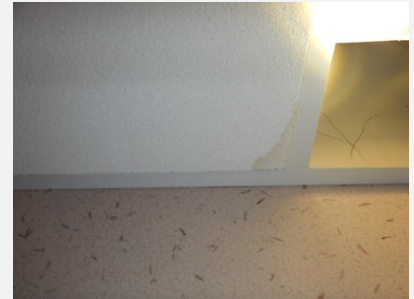
**Stains**- There is evidence of prior leakage at the ceiling tiles in the Suite 2 bathroom (area below water heater). ***We tested this area for moisture and found that it is dry.*** Check with the current owner/occupant for further information about this issue.

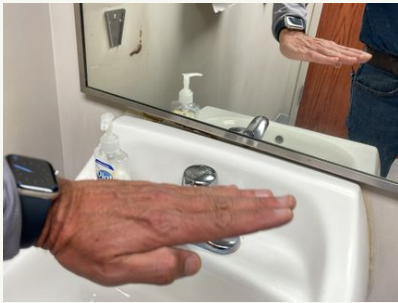
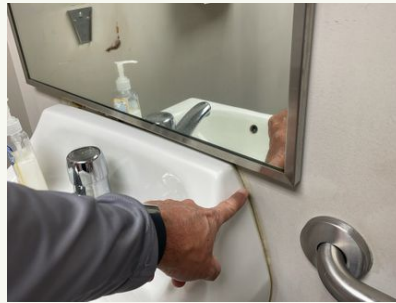
🔧 **(B-3) Maintenance Item:** The sink at the men's bathroom (Suites CDEF common hall) is out of level and missing caulk. A qualified technician should review and reset/re-caulk as needed.

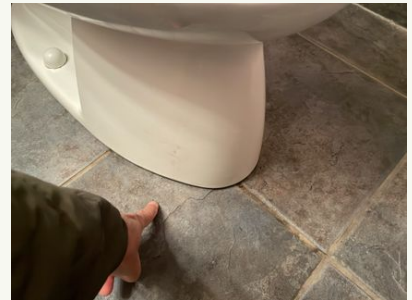
**Caulk toilet at floor?**- Toilets that are set on floor surfaces such as glazed ceramic tiles frequently slip, even if the closet bolts are tight. Applying a bead or fillet of silicone caulking material around the base of the toilet when the joint is dry can prevent slipping.

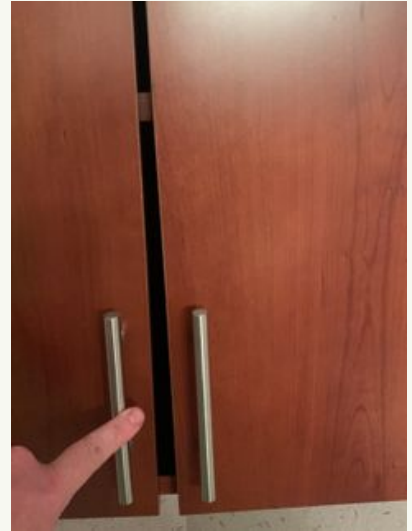
**Vanity doors**- Vanity drawers are misaligned in the Suite B bathroom. A qualified carpenter should make repairs.

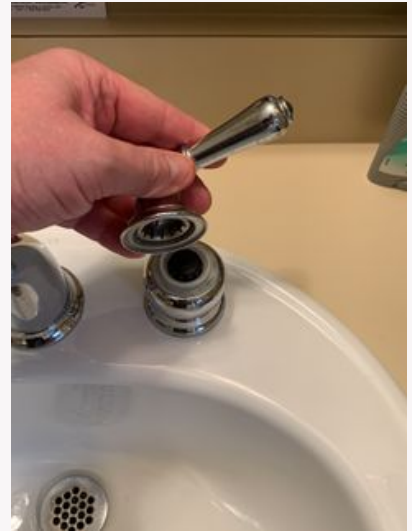
**Faucet issues**- The bathroom faucet cold water handle in the Dr's office is not secured. A plumber can make repairs.
