# Inspection Report

123 Main Street

Anywhere IL

**Dunsing Inspections**

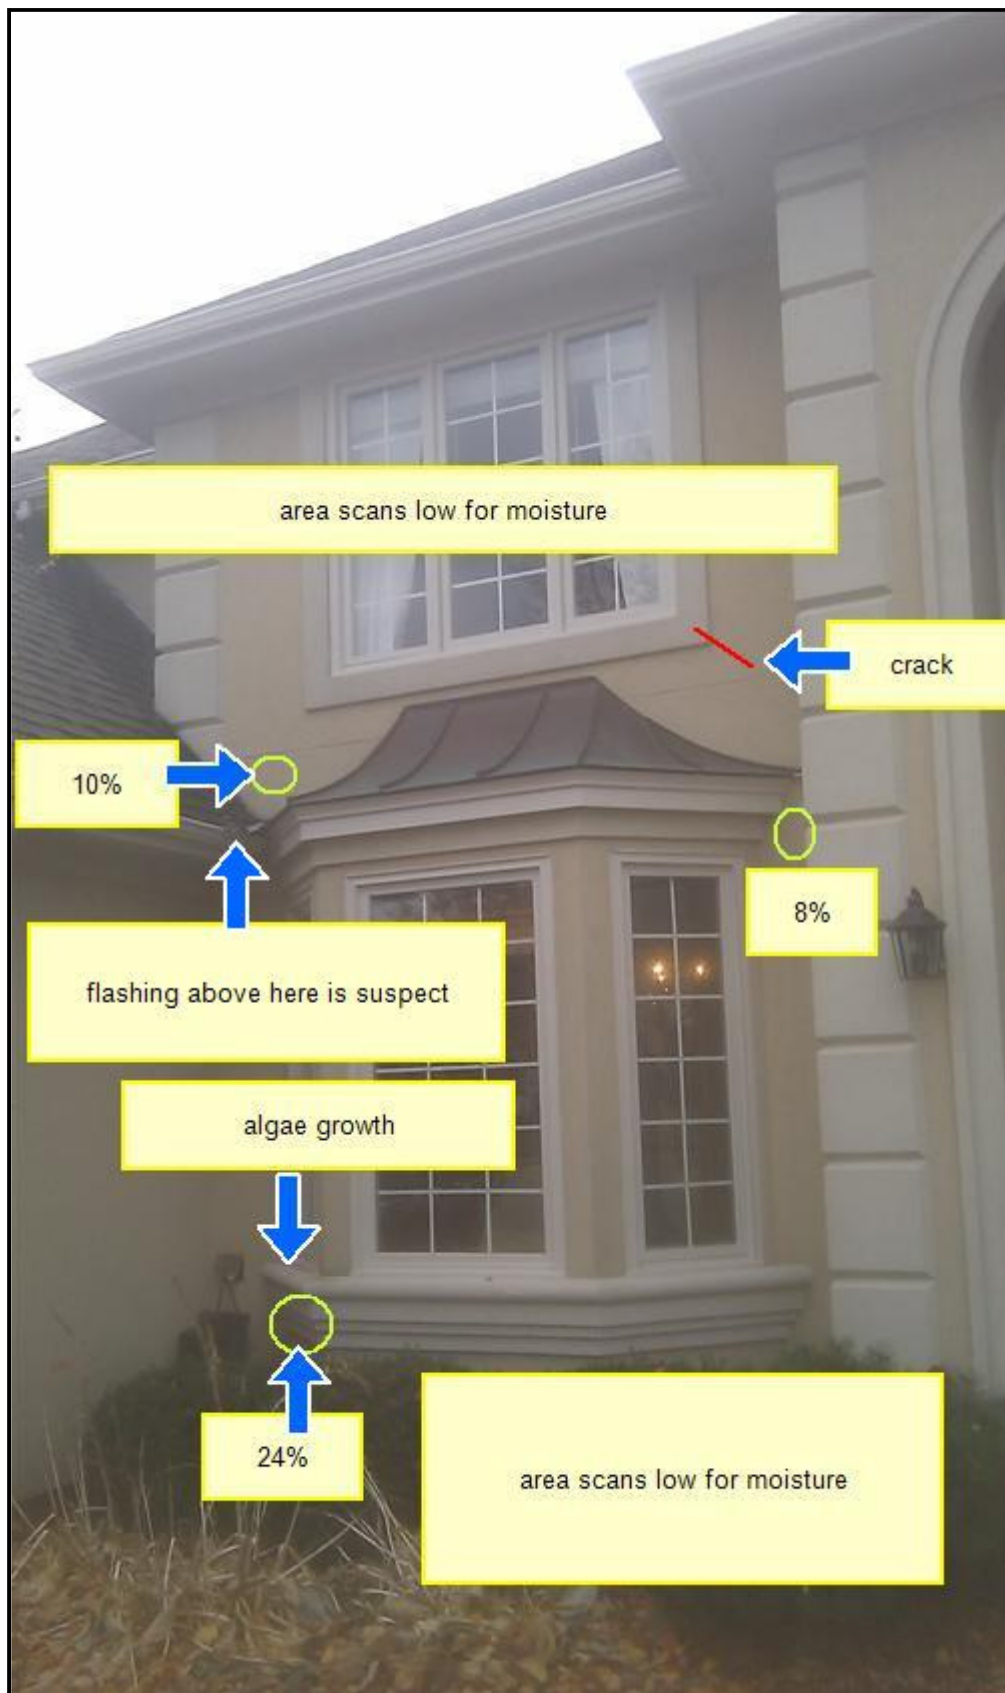
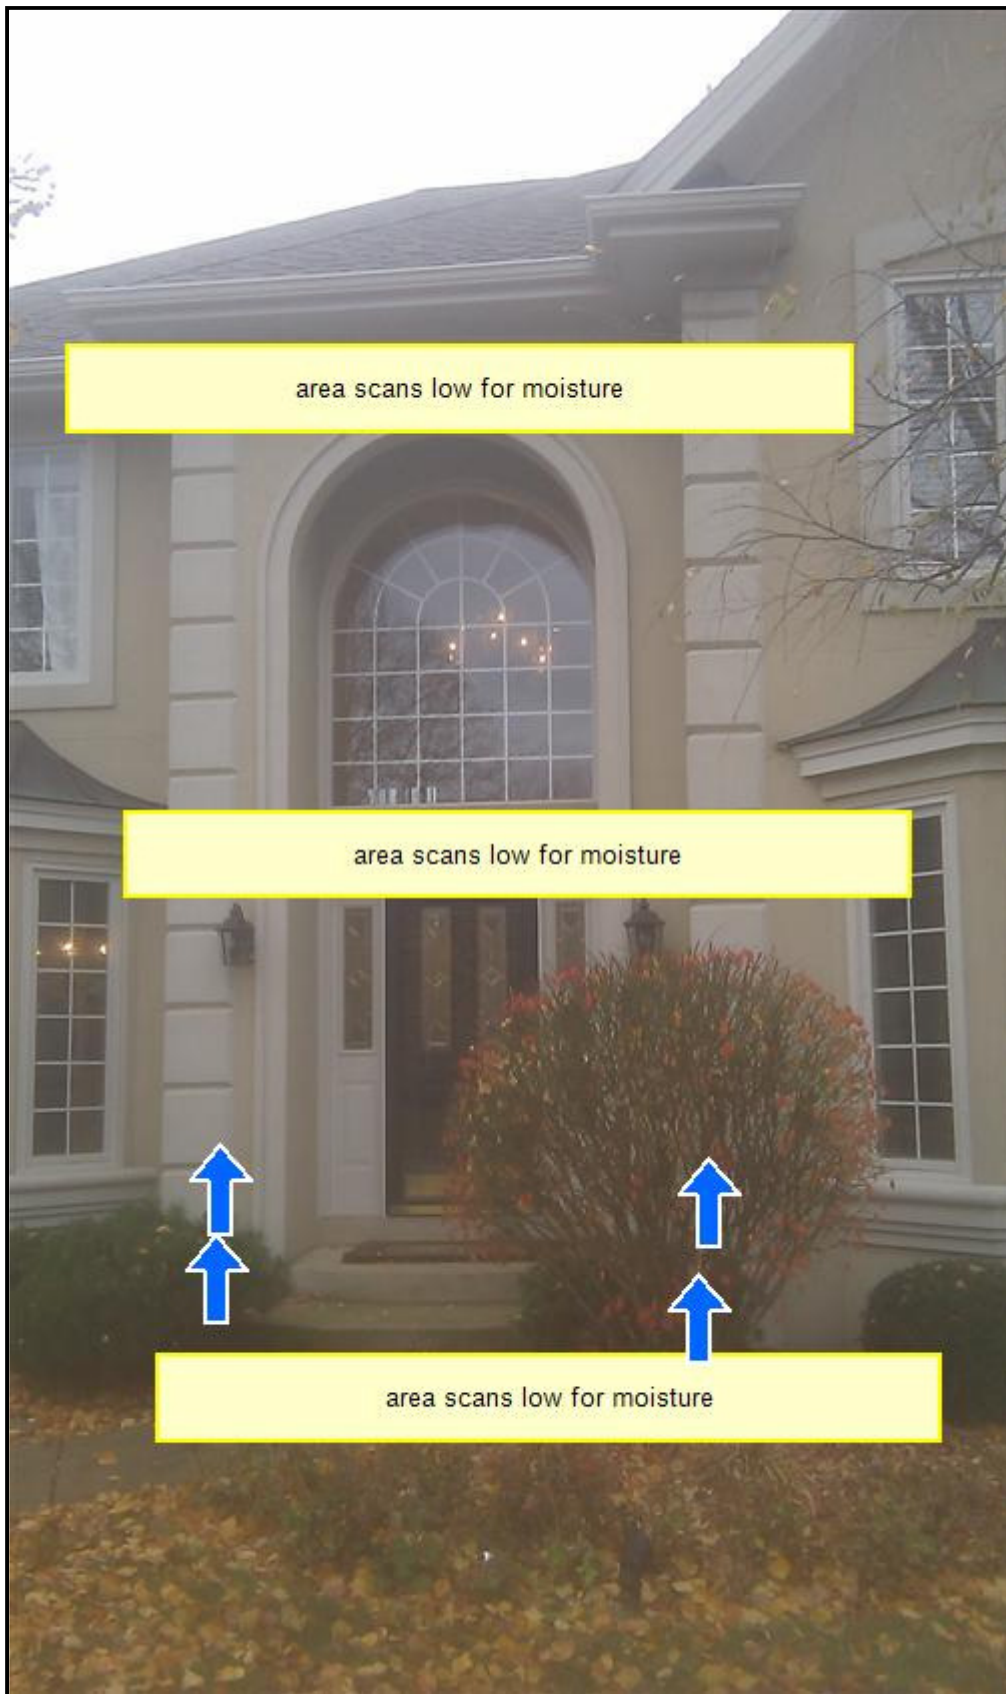
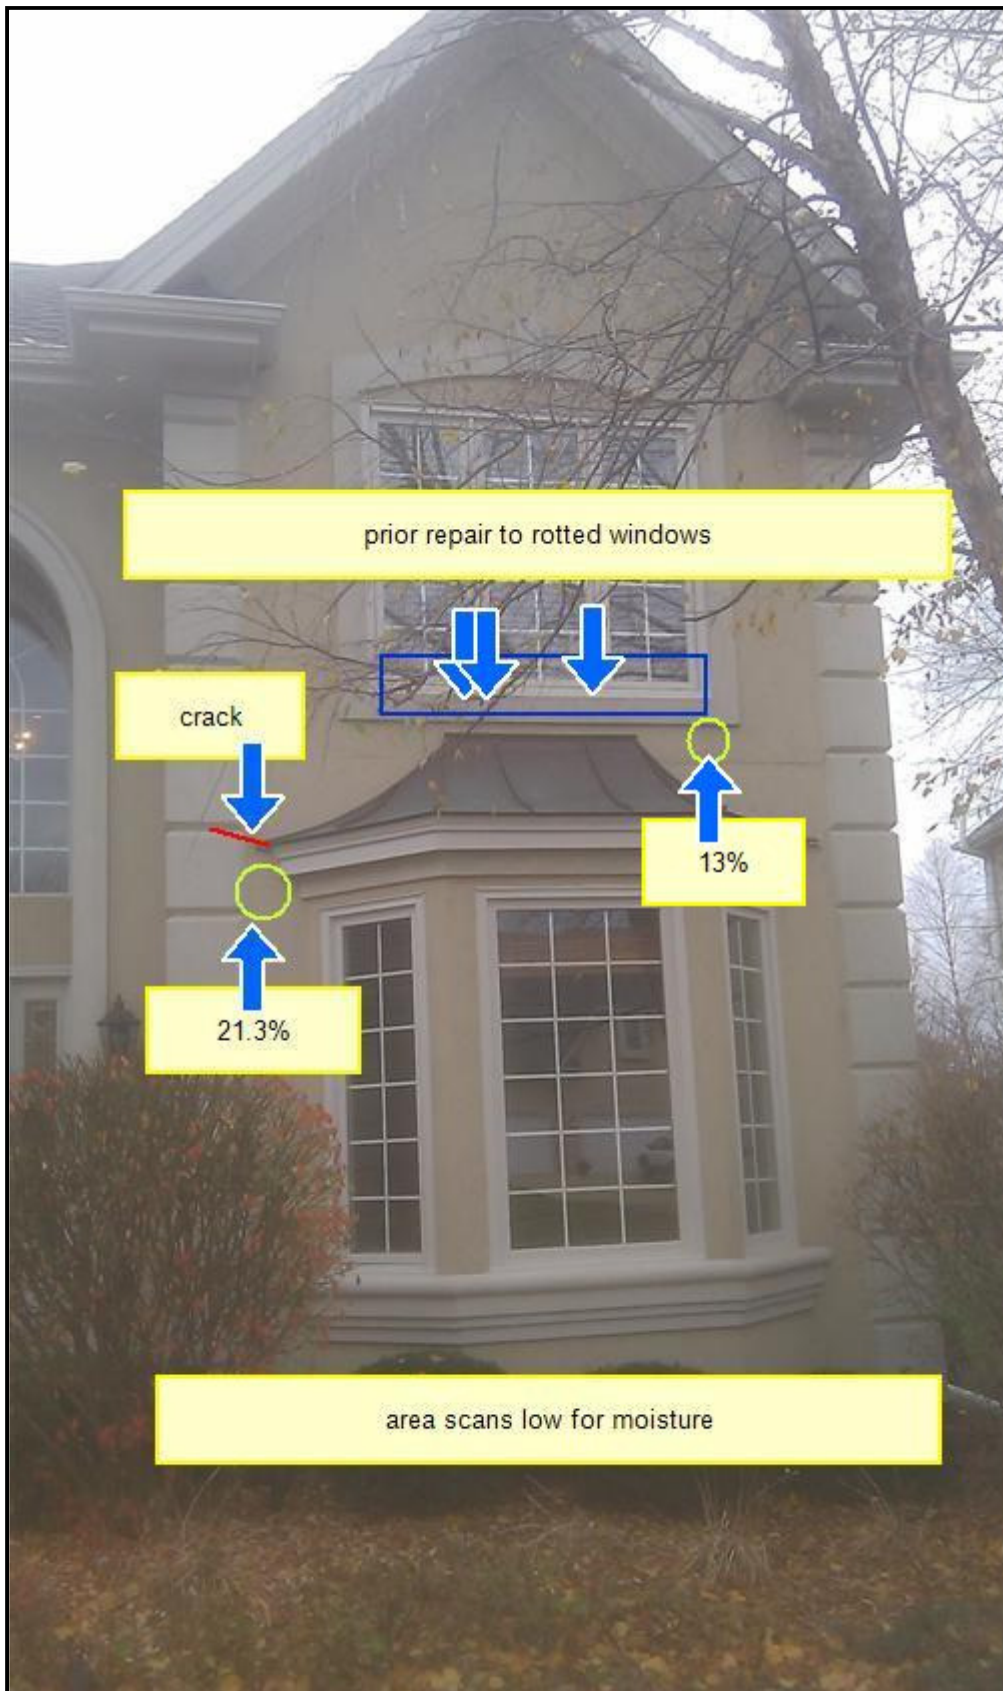
The photo below shows moisture readings. Any photos further down in this section show specific areas of concern. Note that these areas may be common defects at other areas of the building, not simply this location only.

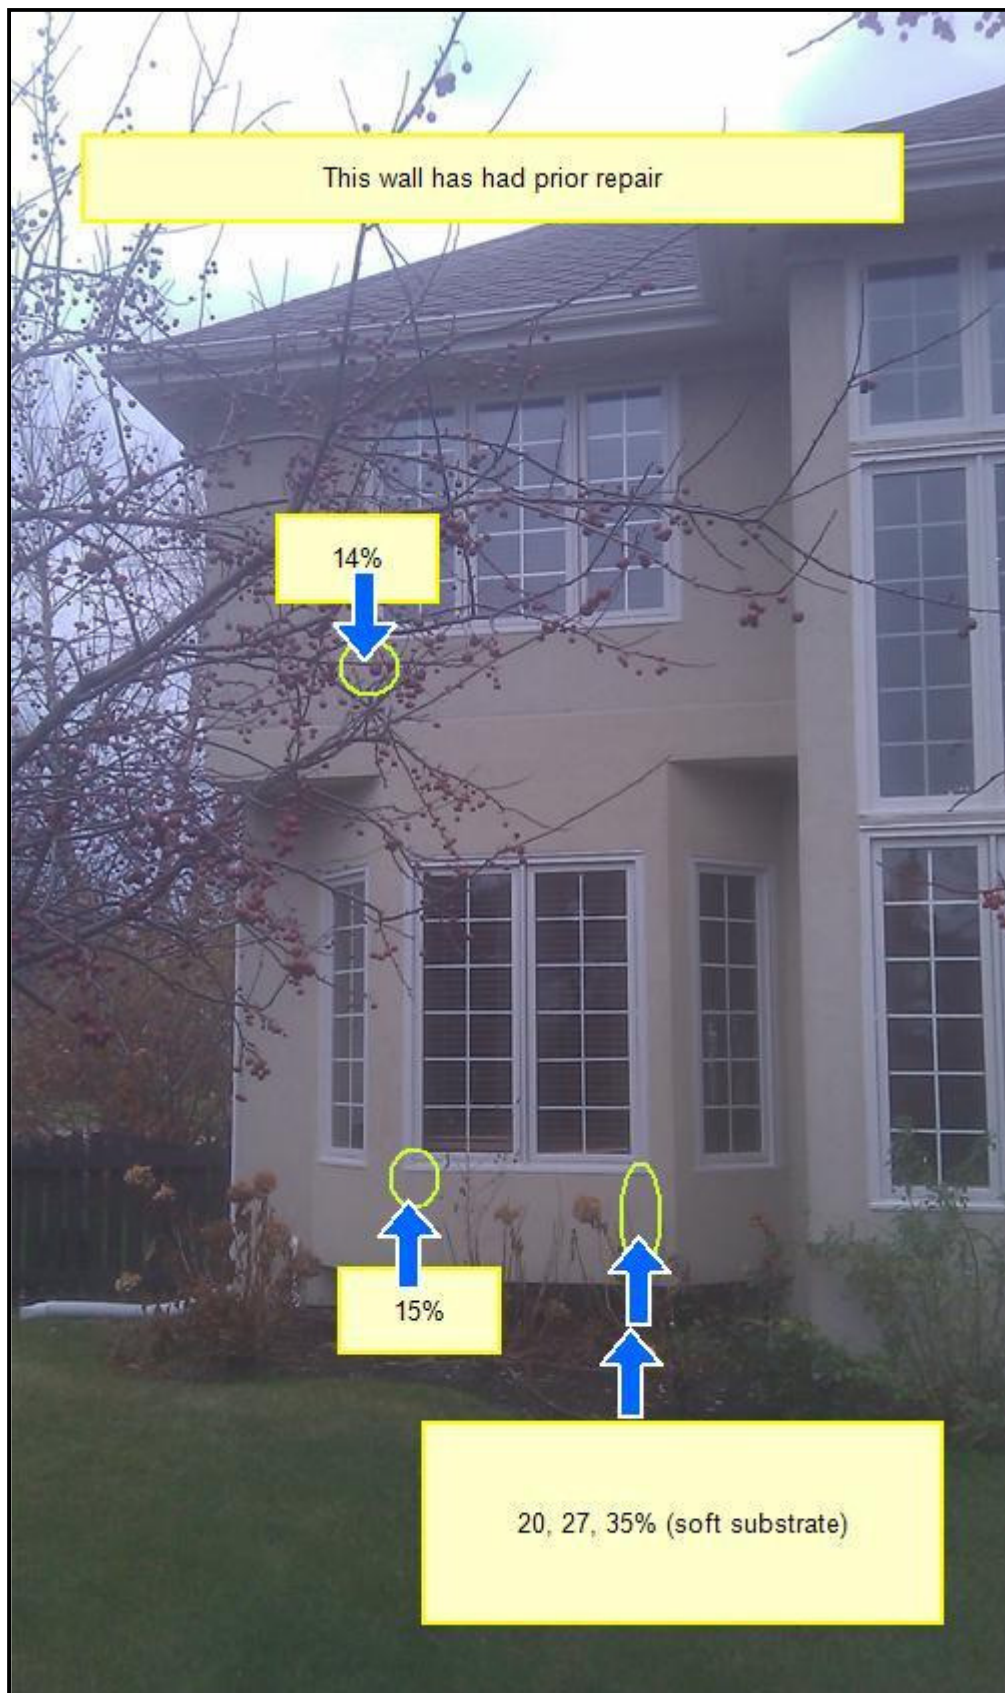
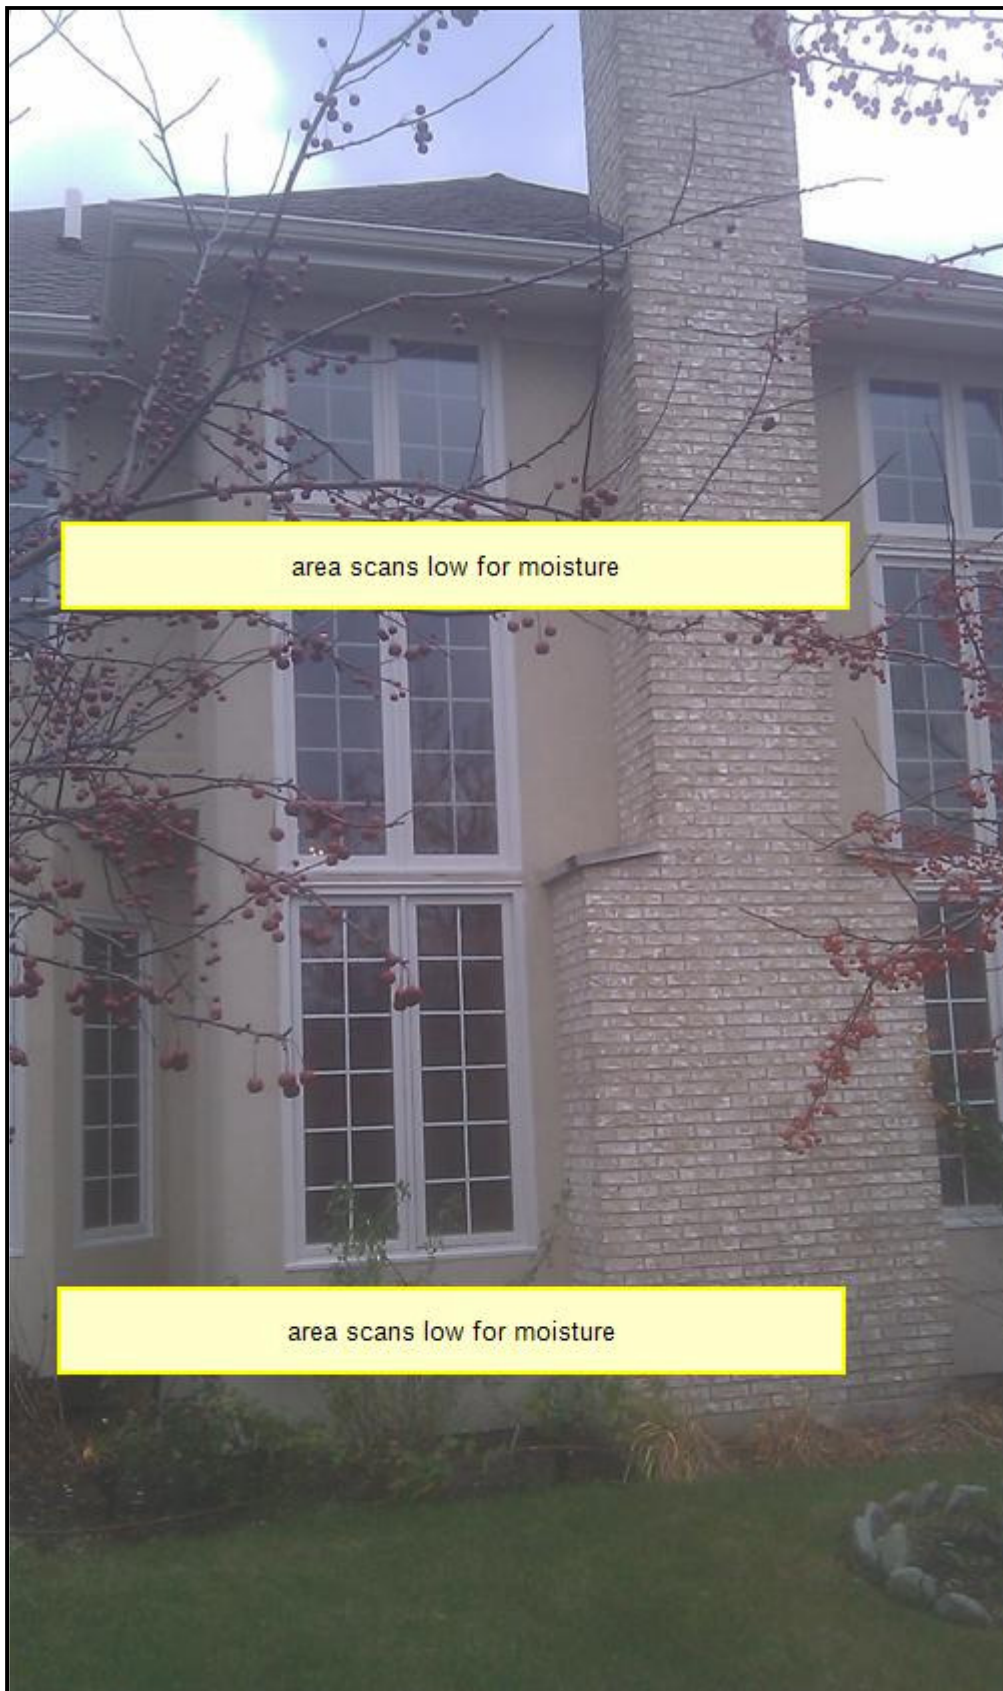
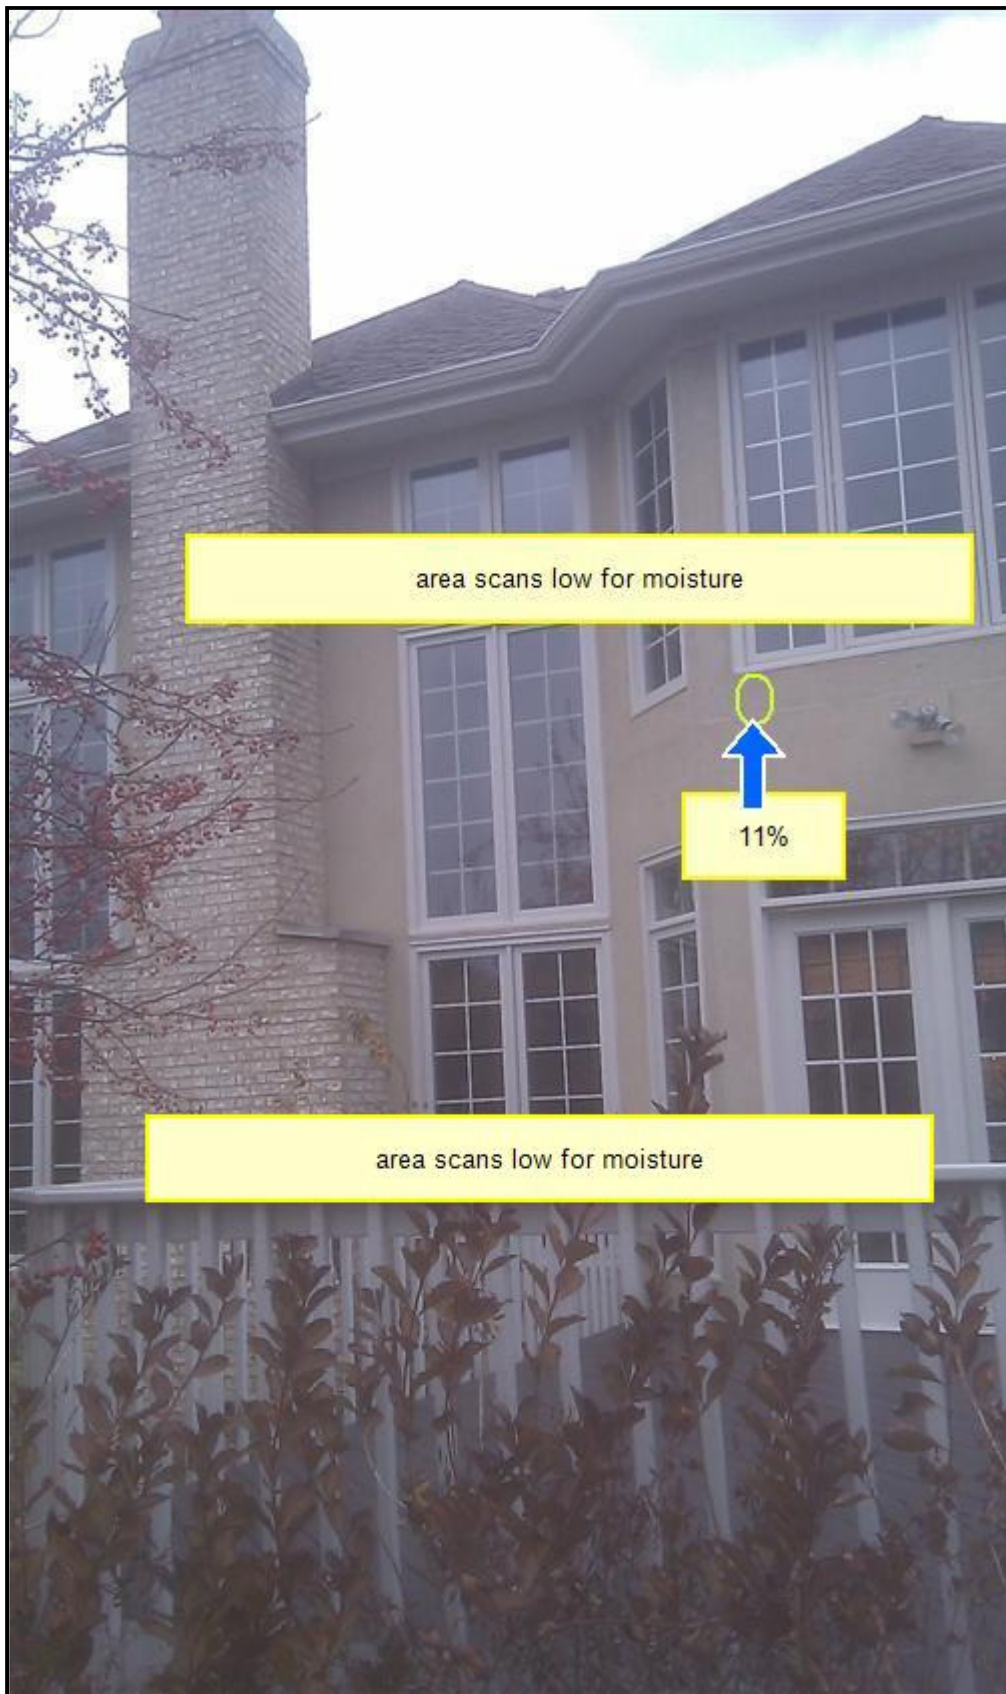
**2(C). Rear**

The photo below shows moisture readings. Any photos further down in this section show specific areas of concern. Note that these areas may be common defects at other areas of the building, not simply this location only.

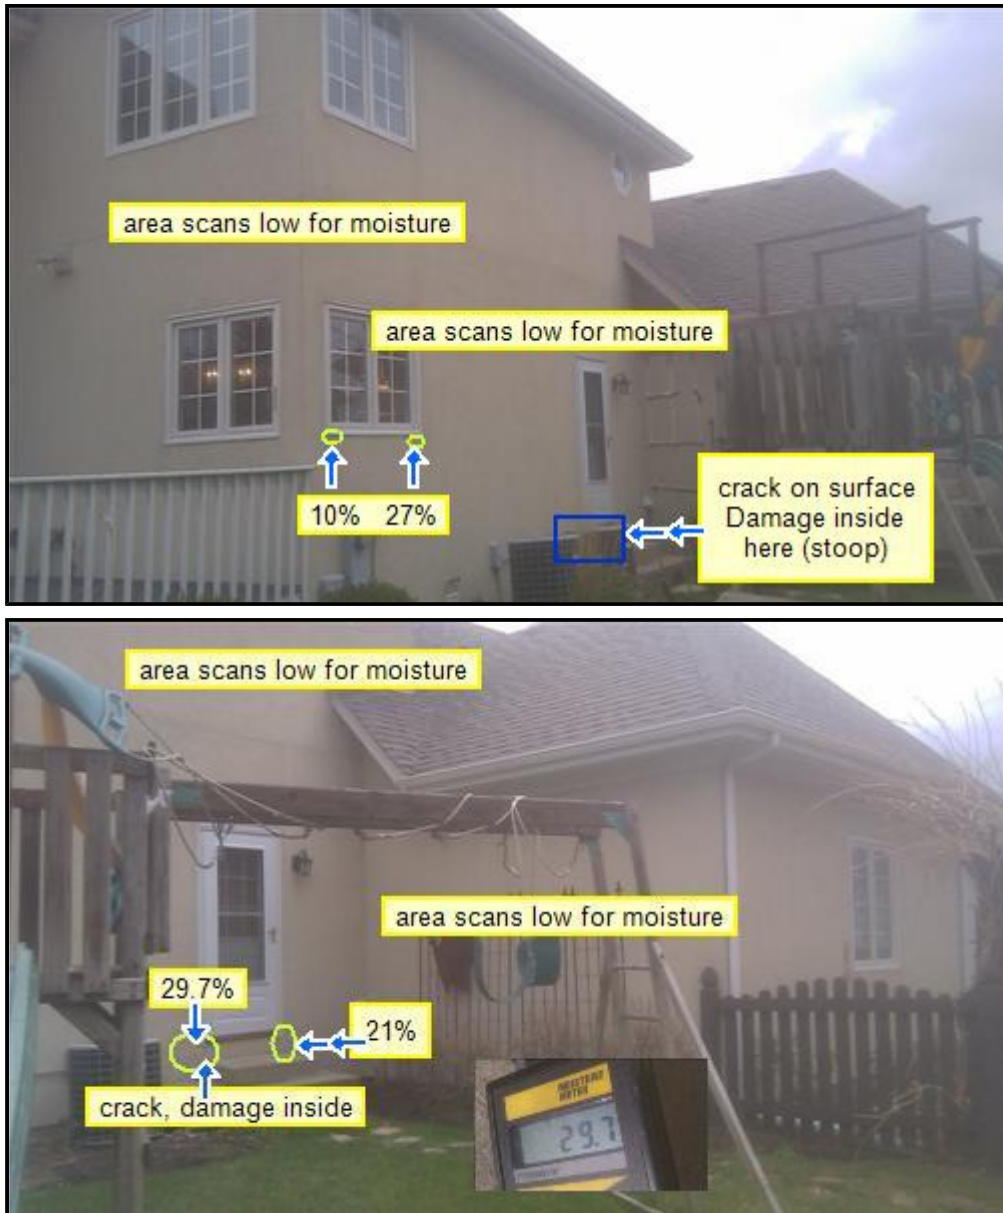
**2(D). Left**

The photo below shows moisture readings. Any photos further down in this section show specific areas of concern. Note that these areas may be common defects at other areas of the building, not simply this location only.
