# Inspection report for the property at Medical building sample report

This report is prepared exclusively for **Sample Report**  
Inspected On: **04-23-2024**

This is a medical facility. There are separate offices for counseling, dentist and other medical professionals. Some of the systems in the building are aging and will require updating.

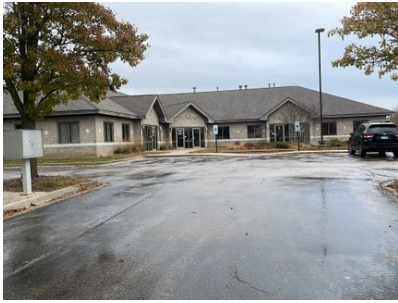
*Front view of building*

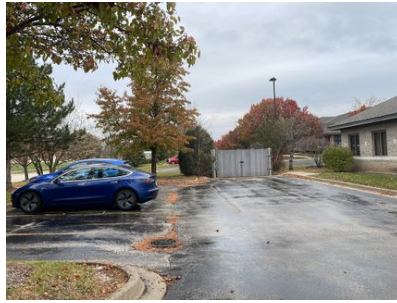
*West Side and parking area*

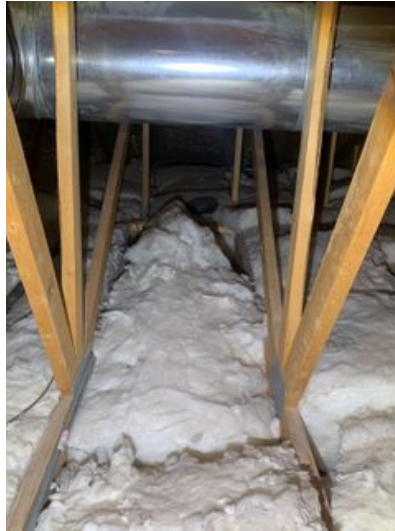
*Attic overview (typical insulation)*

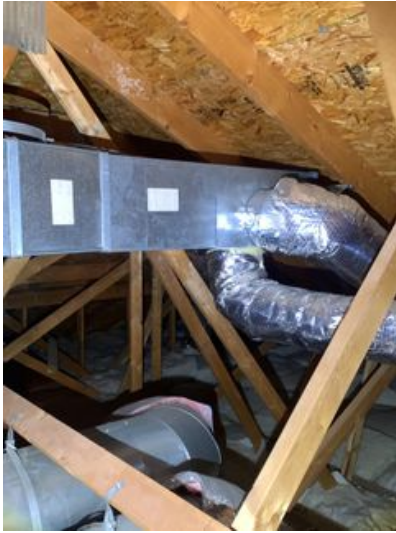
*ductwork in attic space*

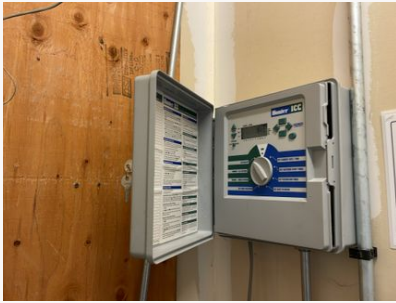
**🚫 (P-5) Items Not Inspected: Sprinklers not inspected-** Operation and evaluation of irrigation (sprinkler) systems is outside of the scope of this inspection. We did note evidence of past leaking (the system is currently shut down).

*timer for sprinkler system*

- **SUGGESTION:** We suggest that you have the owner or a sprinkler technician demonstrate the

irrigation system and any related equipment before closing.
