# Inspection report for the property at Medical building sample report

This report is prepared exclusively for **Sample Report**  
Inspected On: **04-23-2024**

This is a medical facility. There are separate offices for counseling, dentist and other medical professionals. Some of the systems in the building are aging and will require updating.

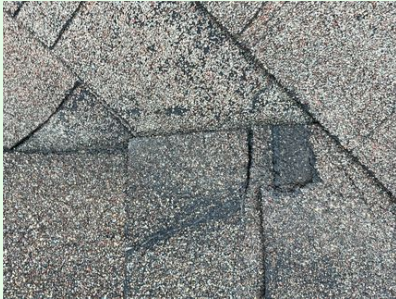
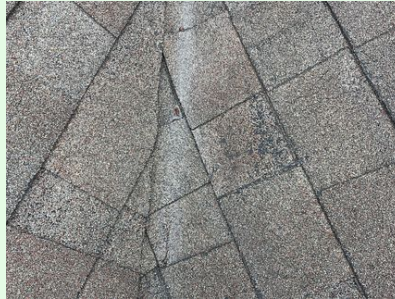
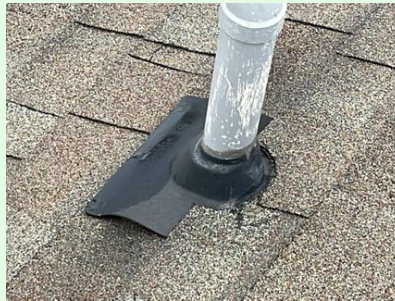
**(R-2) Budget For Replacement: OLD ROOF** This roof is near the end of its expected service life. Granular loss, tears, blemishes, exposed nails and patches are noted. Budget to replace the

roof soon.

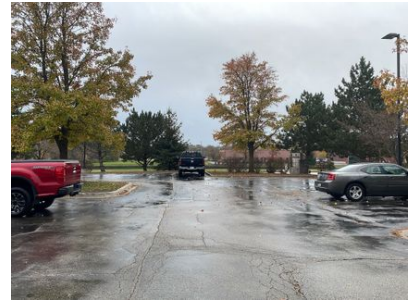
*Parking*

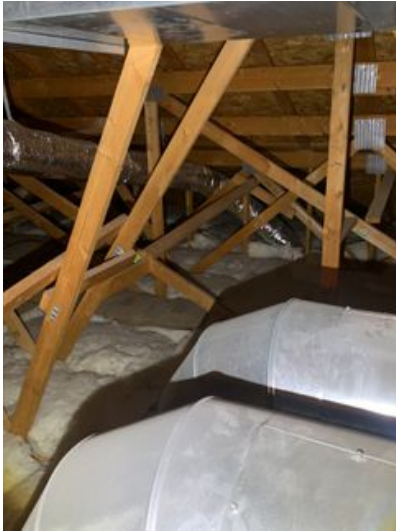
*Attic overview*

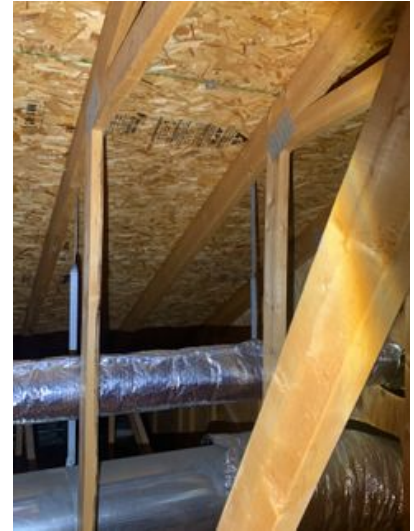
*Attic overview*

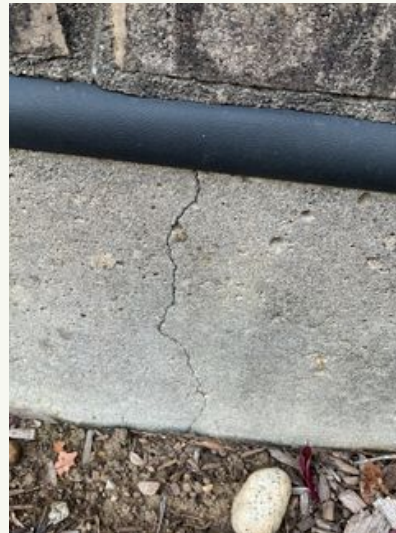
*rear wall*

🔧 **(S-2) Maintenance Item: Wall Cracks**- There are typical cracks at some locations in the foundation slab. We recommend that these cracks be repaired to prevent seepage. Of course, if seepage occurs, a waterproofing contractor should be consulted immediately to seal the cracks. The methods used to seal these types of cracks are usually very dependable and often have a long term warranty.

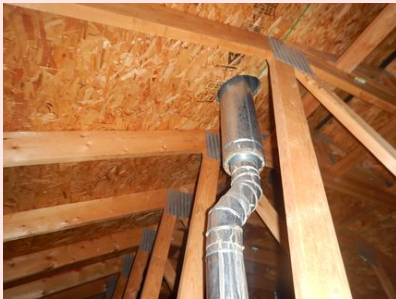
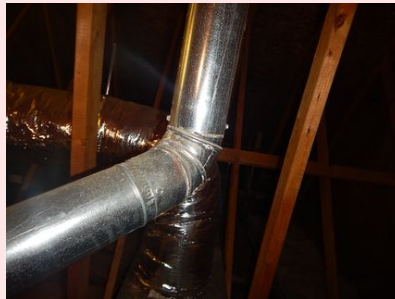
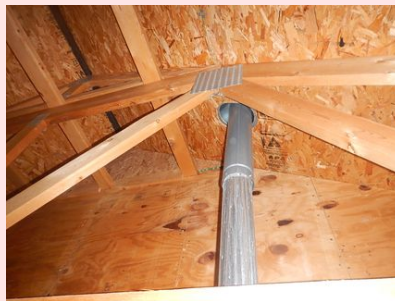
⚠️ **(H-6) Major Concern or Safety Concern:**

**Rust/Corrosion/Holes in vent**- The vent connector has rust, corrosion, or holes in it. This indicates that there is excessive moisture (most likely from condensation). This can cause the heating system to vent improperly. An HVAC contractor should make repairs to make the venting system safe.

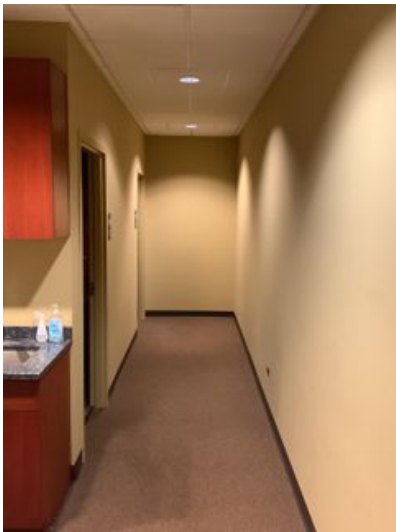
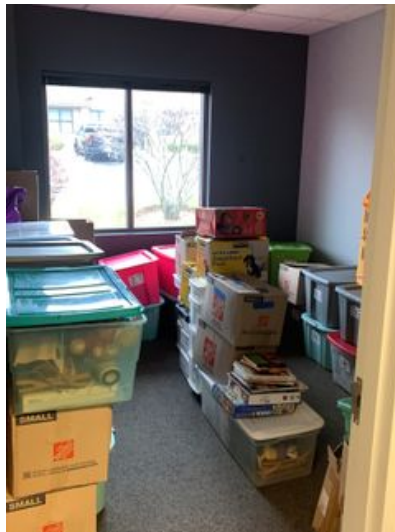
*excessive stored items in unused office*

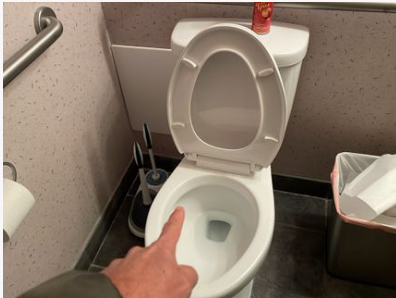
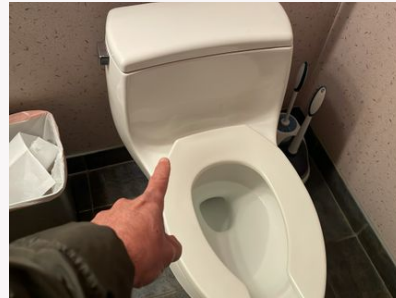
**🔧 (B-4) Items Not Working / Repair: Loose toilet**- The toilets at the Suite B bathrooms are loose at the floor. Repairs are needed to prevent leakage. A licensed plumber should repair or correct as needed.

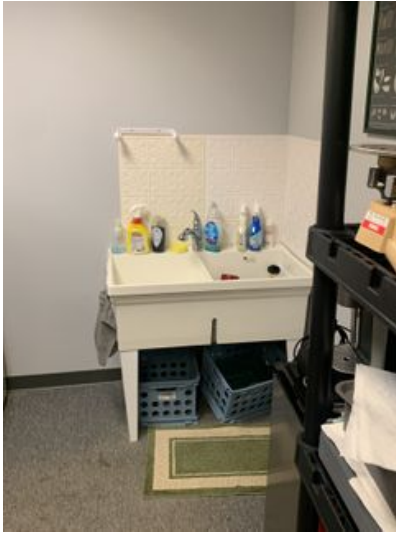
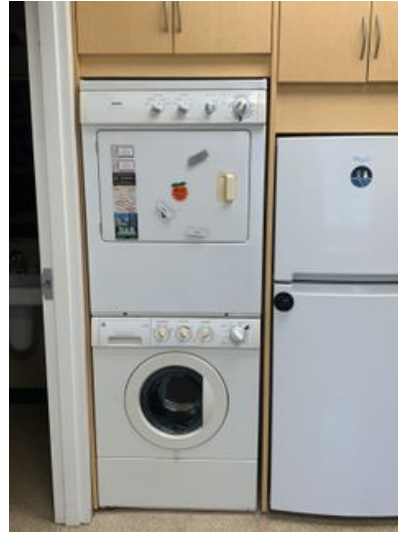
*Laundry at dental office*
